Nassau County Stormwater Management Program

BELLMORE CREEK SUBWATERSHED Stormwater Runoff Impact Analysis AND CANDIDATE SITE ASSESSMENT REPORT

FINAL – October 1, 2007

CASHIN ASSOCIATES, P.C.
Engineering • Planning • Construction Management

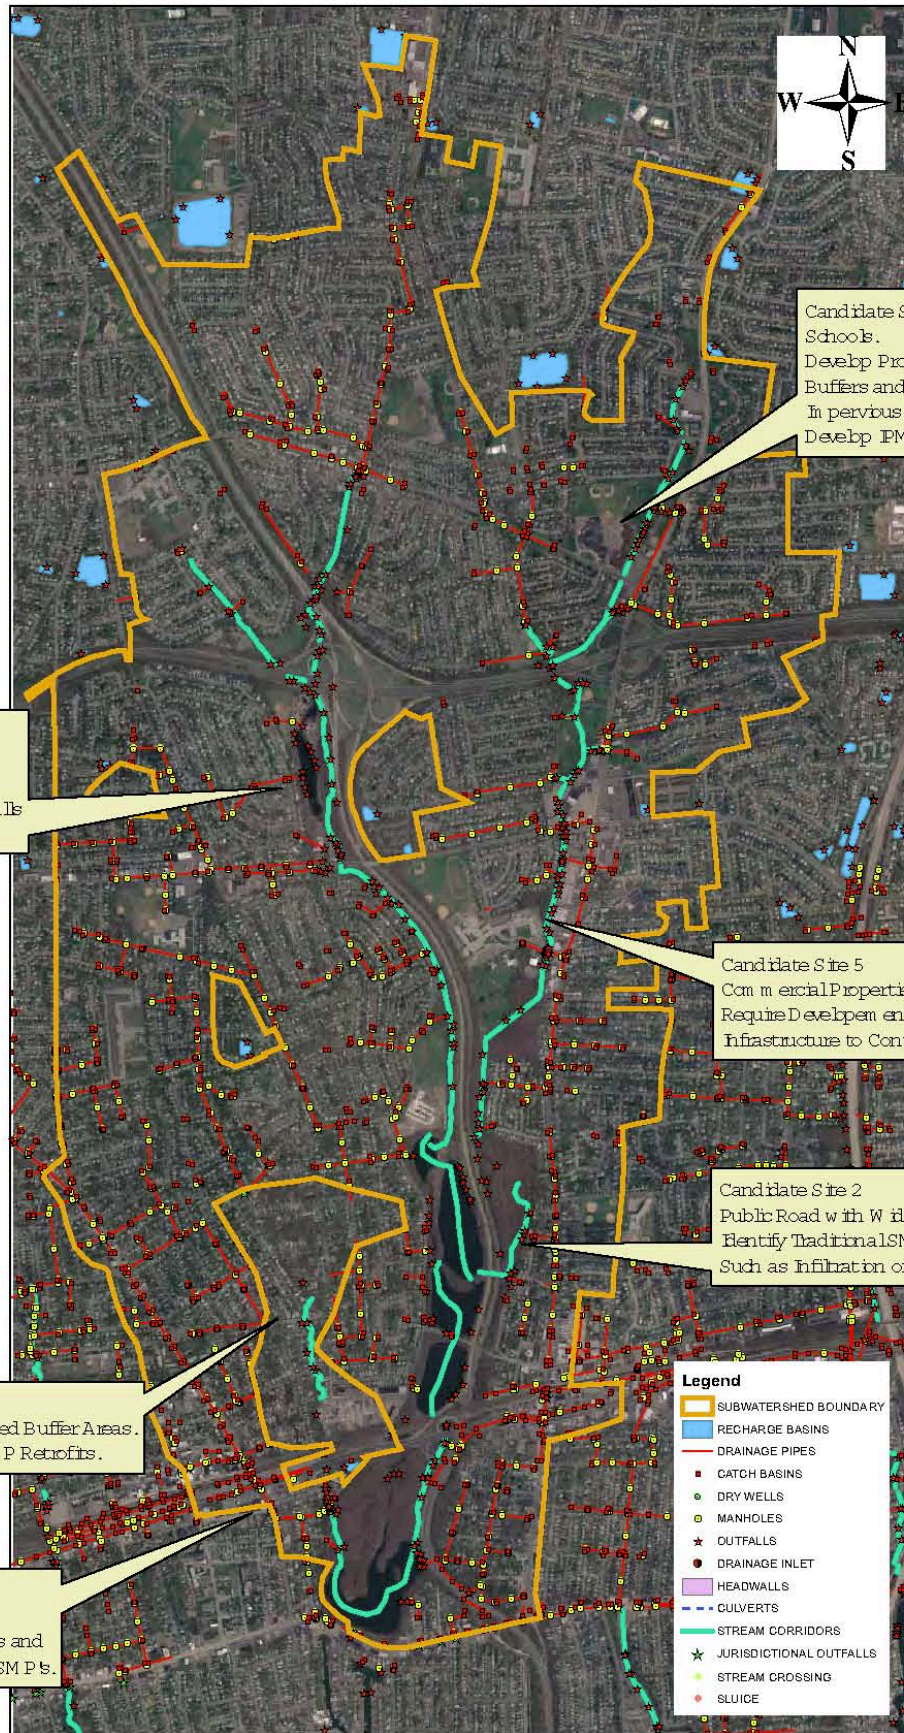
**MAP 3-1
NASSAU COUNTY STORMWATER
MANAGEMENT PROGRAM
STORMWATER RUNOFF IMPACT ANALYSIS
SMP CANDIDATE SITE MAP
BELLMORE SUBWATERSHED**

Candidate Site 1
State Roads.
Work with State to
Identify SMPs for Outfalls
from State Roads.

Candidate Site 6
Schools.
Develop Programs to Vegetate
Buffers and Provide SMPs for
Impervious Surfaces.
Develop PM Programs.

Candidate Site 2
Public Road with Wet Buffer Areas.
Identify Traditional SMP Retrofits
Such as Infiltration or Filtering Practices
