**Nassau County  
Office of the Comptroller**

**Report on Super Storm Sandy Tree Removal at  
Searingtown Road, Shelter Rock Road and Welwyn Preserve**

**August 1, 2013**

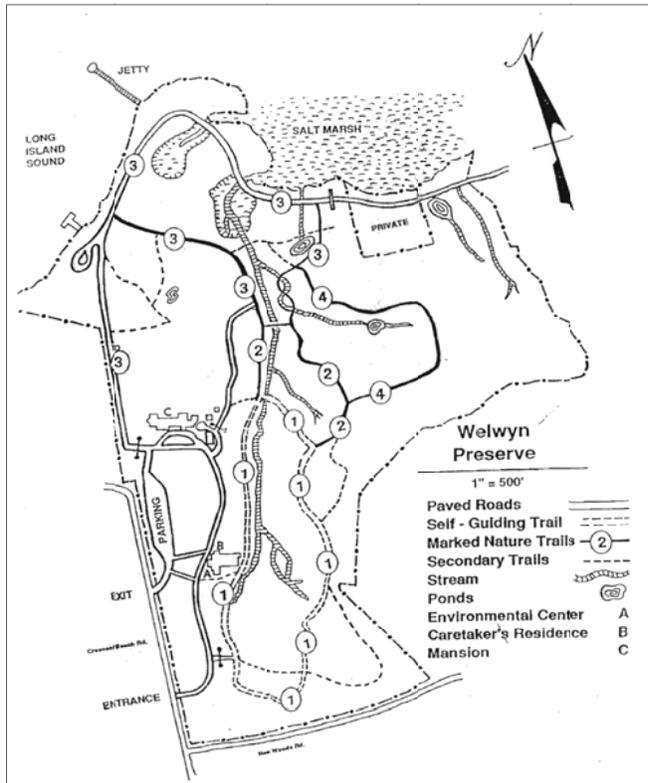
**Exhibit 1**

The auditors visited the Welwyn Preserve to make first hand observations. They walked most of trail number 1 (See Exhibit 1) which, according to the DebrisTech map (see Exhibit 2), was the area where most of the trees were cut within the preserve.

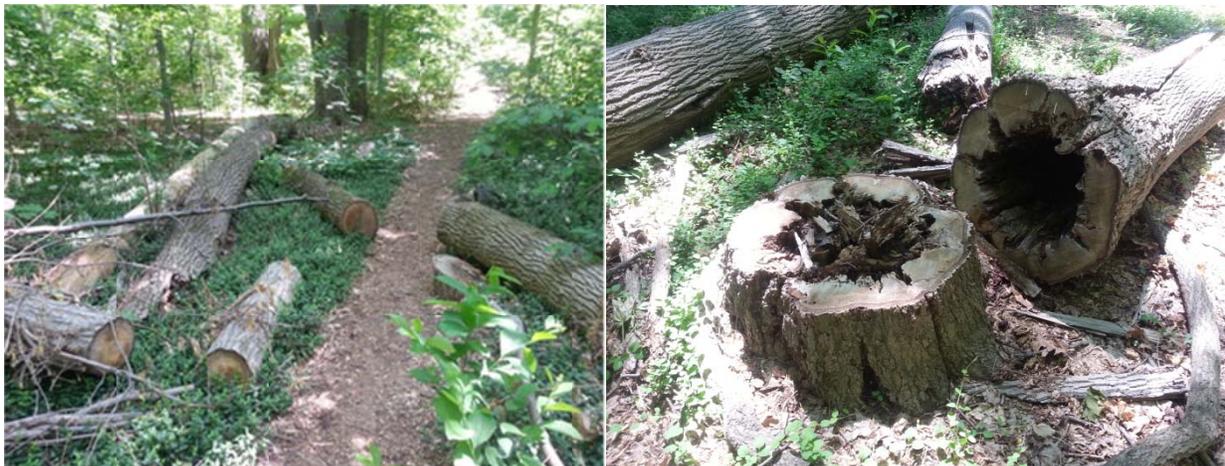
The auditors observed trees that appeared to be cut because they were diseased, insect infested or damaged. Left standing, these trees may have posed a threat to hikers if the tree fell. See pictures below.

The auditors did not find any specific area where a large number of trees were indiscriminately cut down. The trees that were cut down appeared to have been cut for safety purposes and were scattered apart from one another. There were a few very large trees that apparently fell on their

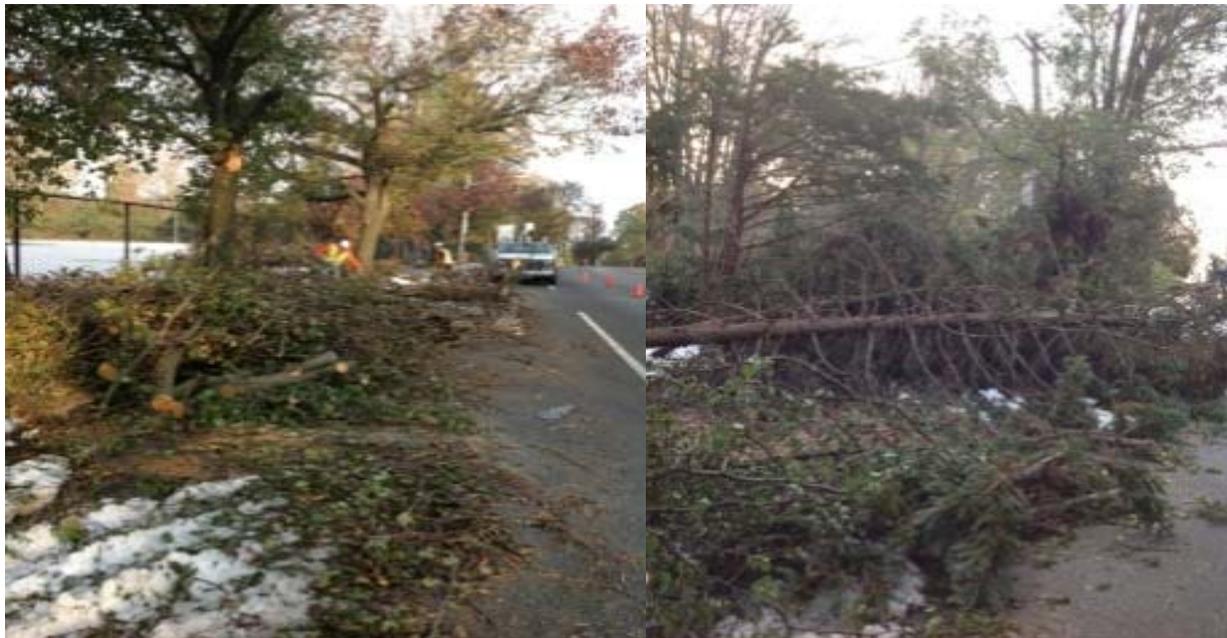
- were previously pruned in the middle of the crown due to power lines above;
- were previously damaged by passing cars and trucks that continued to cut back one side of the tree, causing the weight to be unevenly applied to a weak trunk; and
- had weak root structures since the sidewalk and streets are on each side of the trunk.

Other Nassau County roads lined with Bradford Pears and other problem trees are Westbury Avenue in Carle Place and Dutch Broadway in Elmont, both of which experienced problems similar to those on Shelter Rock Road and Searingtown Road.

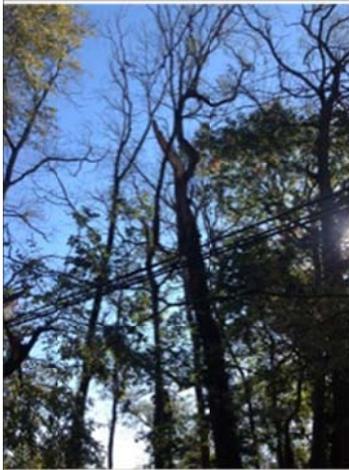
same pic for two tickets

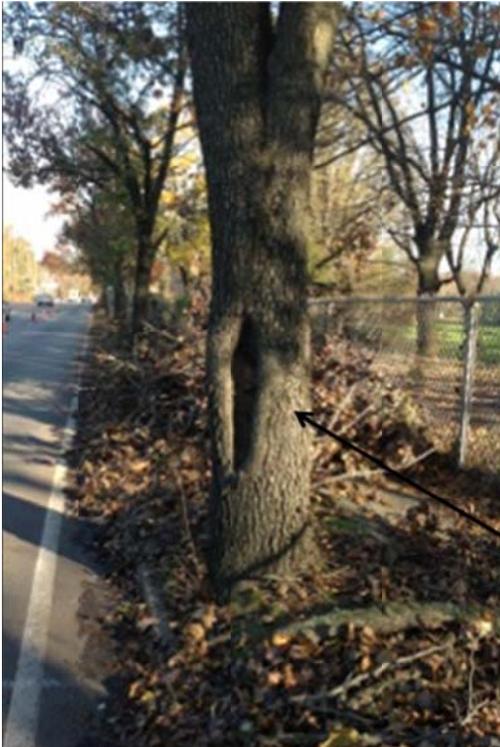
Tree is missing bark from trunk due to older damages but new growth is visible on bark's edge. insect or disease created cavity in trunk. photo does not show new storm related damages to

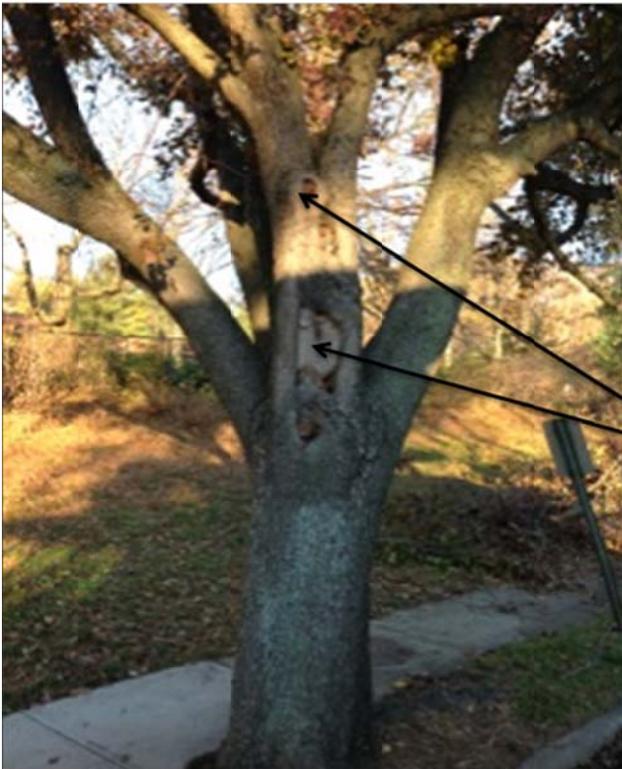
Tree is missing bark from trunk due to older damages but new growth is visible on bark's edge. insect or disease created cavity in trunk. photo does not show new storm related damages to justify the harvesting of this tree

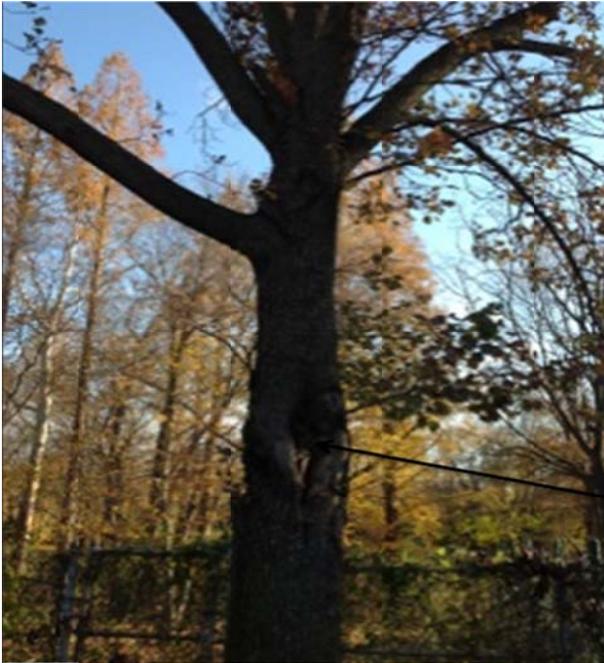
Tree is missing bark from trunk due to older damages but new growth is visible on bark's edge. insect or disease created cavity in trunk. photo does not show new storm related damages to justify the harvesting of this tree

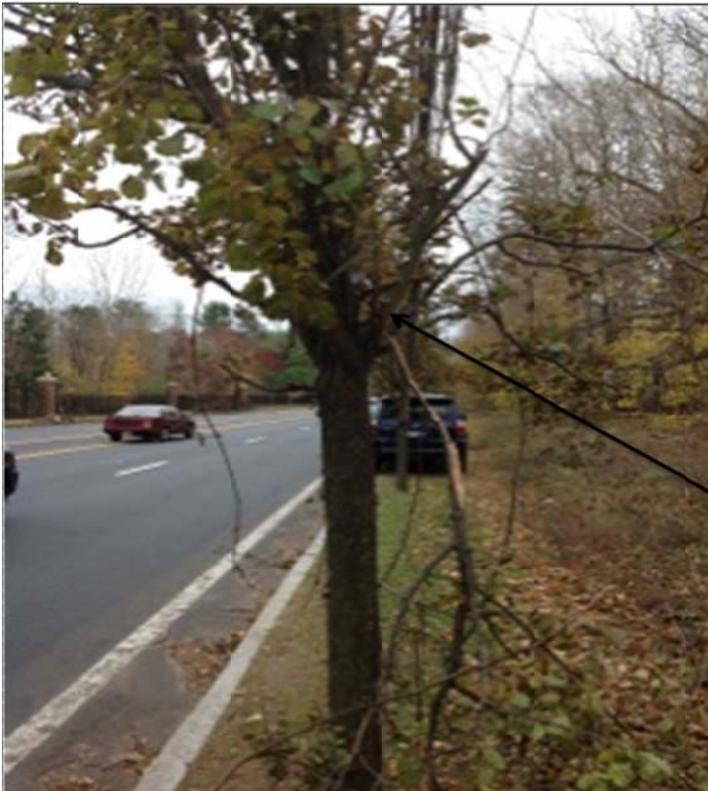
Photo does not show storm related damages to justify the harvesting of this tree

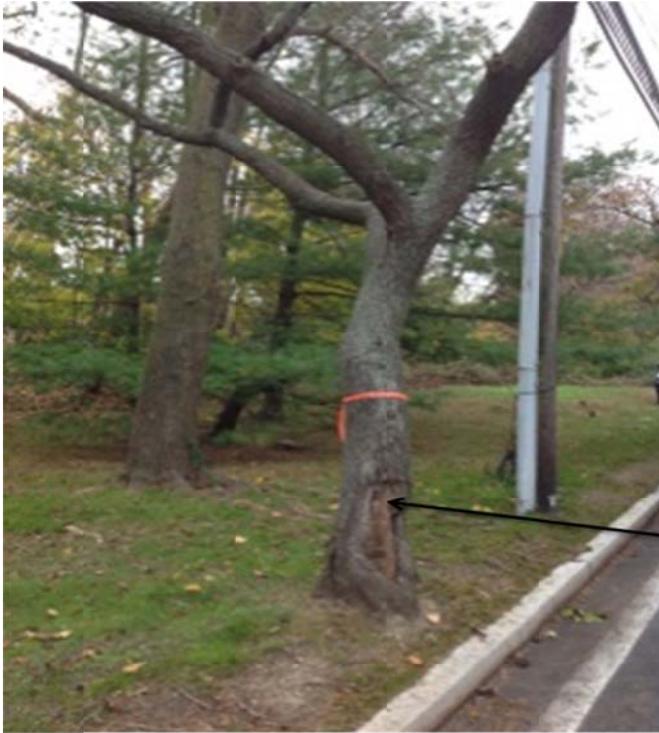
Tree is missing bark from trunk due to older damages but new growth is visible on bark's edge. insect or disease created cavity in trunk. photo does not show new storm related

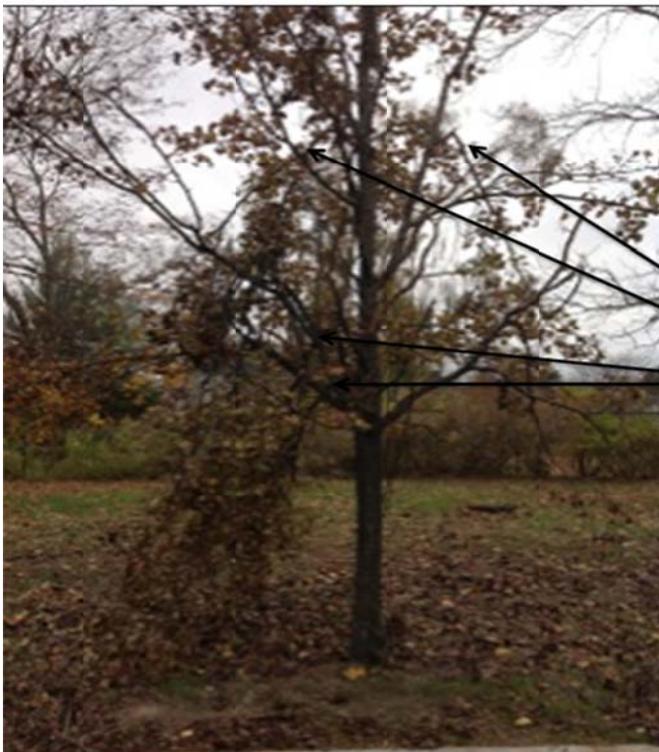
Photo does not show storm related damages to justify the harvesting of this tree. There are 4 hazardous hanging limbs but the tree's crown and rootball are still intact.

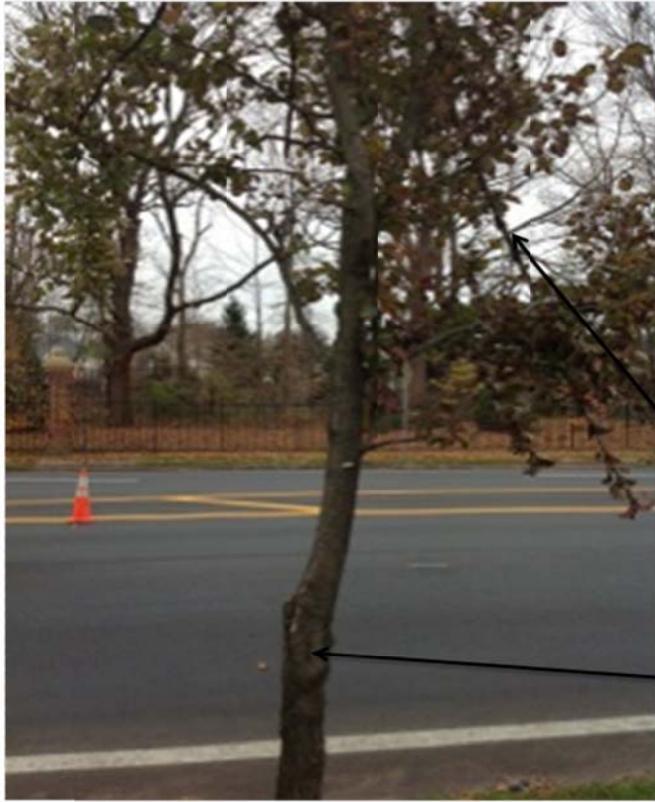
photo does not show storm related damages to justify the harvesting of this tree

Tree is missing bark from trunk due to older damages but new growth is visible on bark's edge.

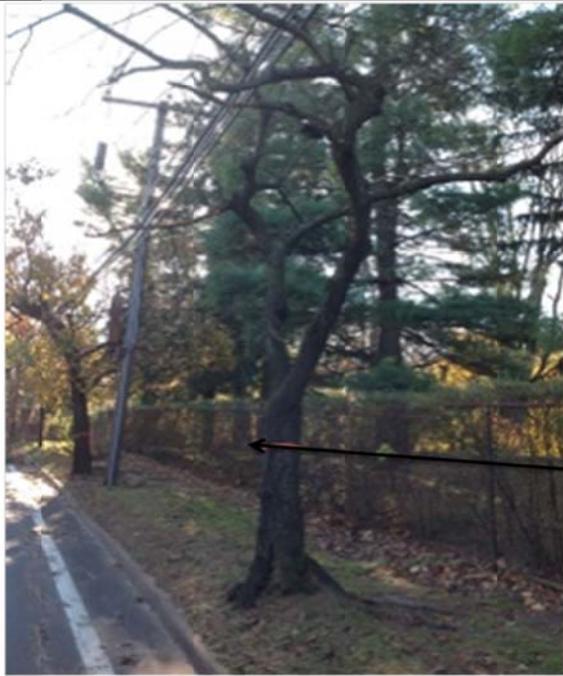
**Dead tree on ROW**

photo does not show storm related damages to justify the harvesting of this tree

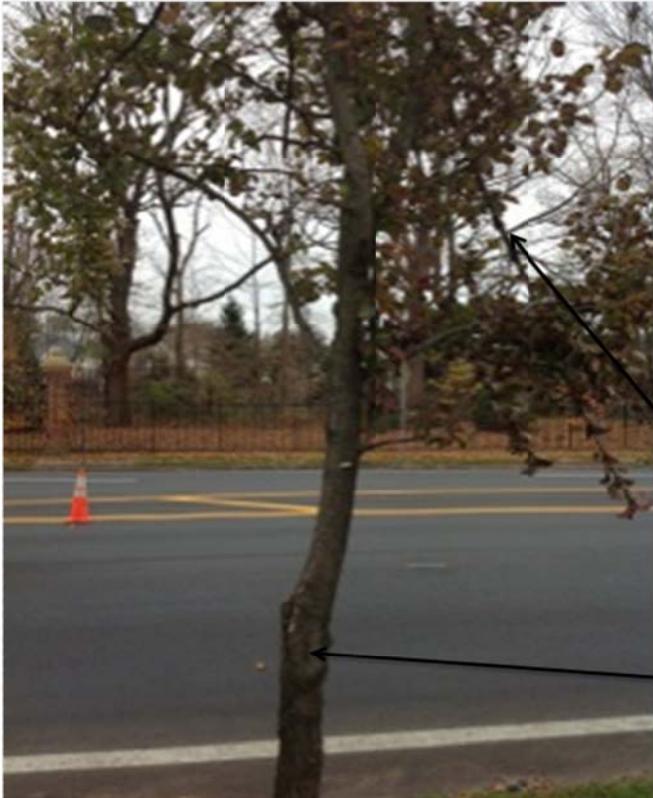
photo does not show storm related damages to justify the harvesting of this tree

Tree is missing bark from trunk due to older damages but new growth is visible on bark's edge.

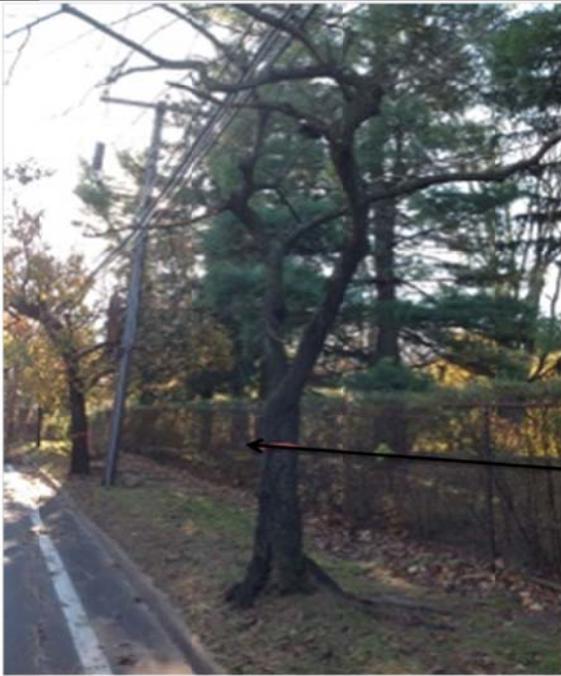
**Dead tree on ROW**

photo does not show storm related damages to justify the harvesting of this tree

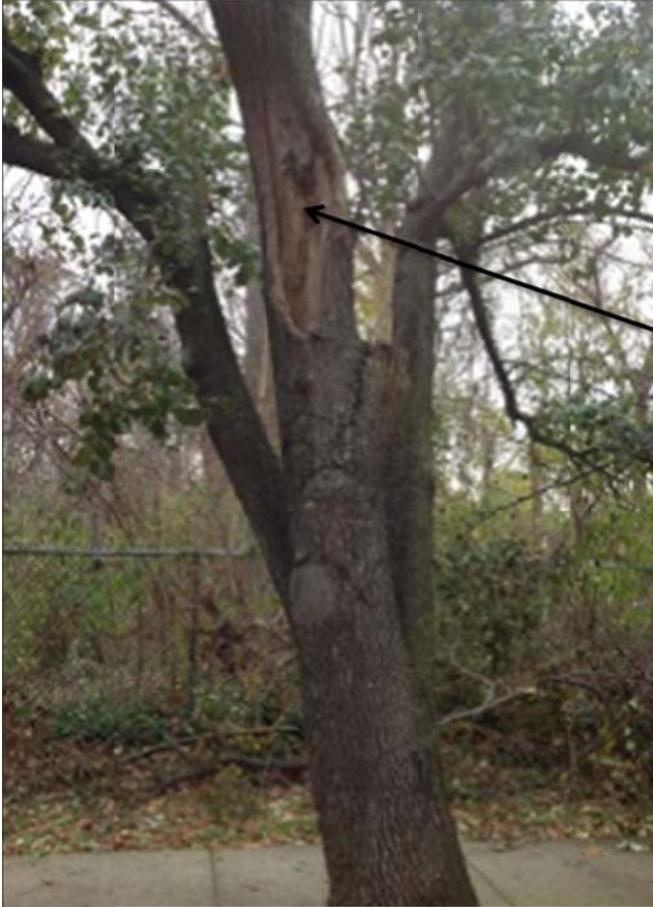
Tree is missing bark from trunk but new growth is visible on bark's edge. insect or disease created cavity in trunk. photo does not show new storm related damages to justify the harvesting of this tree
